Case studies for North of England Members

Heavy weather injury

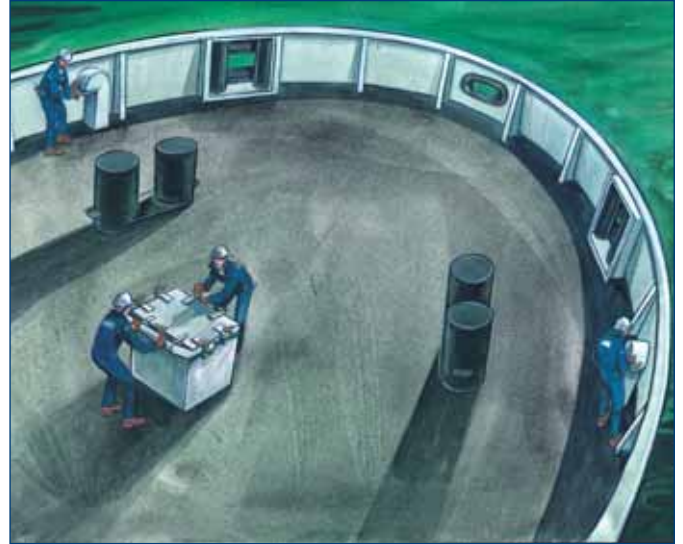
While he was closing the ventilator flaps a particularly large wave broke over the focsle. The chief officer was knocked over by the force of water and his leg was caught in a deck fitting and broken. He managed to get to the focsle intercom to raise the alarm and he was then rescued by the ship's emergency party.
