CHIRP MARITIME FEEDBACK

Issue No: 39

02/2015

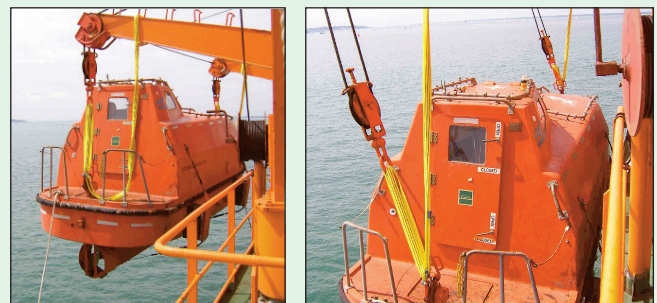
The Industry Lifeboat Group (ILG) continues to apply pressure where it can promoting good practice such as the use of Fall Preventer Devices (FPD) and hanging off pennants used to by-pass the hook. Photographs below show FPDs (between hanging-off lug and fall) and Hanging-off pennants (between hanging-off lug and davit arm) rigged for use.

It is important that FPDs are made of resilient material that can absorb shock. In the photo the same principle has also been applied to the hanging-off pennant. This ensures any failure of the hooks would not induce a large shock loading, which in a wire or chain could cause the latter to sequentially fail as the materials have limited resilience. Furthermore, as can often be found in incident reports, corrosion in wires can be present and could cause weakening of wire strops.

disruptive loads can occur they too can be by-passed by hanging-off or maintenance pennants that attach the boat directly to the davits (see photo). There have been some notable accidents recently in which falls parted and many seafarers paid with their lives (7 lives in 3 accidents!). We will discuss this in more detail in a future edition of Maritime FEEDBACK.

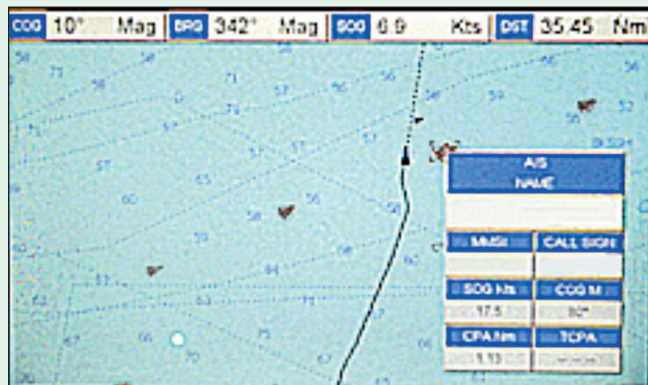
Report Text: We were sailing from Cherbourg to Southampton via the Needles on a 10 metres sailing yacht equipped with an AIS (Automatic Identification System) transponder and active radar reflector. Visibility was about 4 miles, our speed about 8 knots. As we crossed the eastbound shipping lane, several AIS targets were approaching on the port side and eventually became visible. One was of concern because the closest position of approach (CPA) was almost zero. The speed of this ship, the xxxxxx, was about 18 Knots. After monitoring the situation for some time, I called up on VHF radio and informed the crew who answered, that according to our AIS our CPA was near zero. The response was 'I agree'. I then asked if he planned to alter course to avoid risk of collision and he replied in the negative.

I politely pointed out that we were a sailing vessel and the stand on vessel under the Collision Regulations and asked once again if he would alter course. The reply was 'I could do but I'm not going to'. I decided at this point that further discussion was unlikely to be productive, ended the conversation and instructed the helm to turn 20 degrees to port and harden up the sails. This allowed us to pass behind the ship by a safe distance.

Lessons Learned: Do not assume that another vessel will take avoiding action even if it is aware that a risk of collision exists.

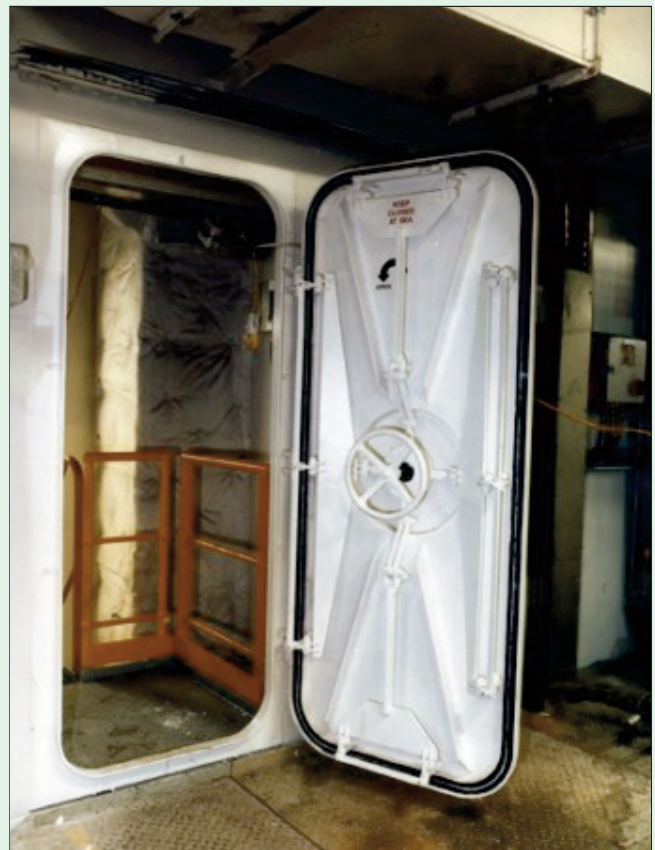
Report Text: A watertight door left open and unsecured on main deck. This created potential injury to limbs. Causal factors: Failure to follow procedures and an inadequate securing system.

CHIRP Comment: Leaving these doors permanently open at sea increases the risk of progressive flooding and loss of stability. International Convention for the Safety of Life at Sea (SOLAS) describes how watertight doors should be used, including how and when these doors can be left open and when they need to be closed. Vessel management teams are encouraged to ensure that all personnel are aware of the risks and that watertight doors are kept closed and to use all of the dogs.

There is a need to improve safety awareness onboard; hazards can be encountered in all onboard activities including the routine ones. Hazards are controlled through the implementation of the Company Safety Procedures, onboard training and good seamanship practices. A moment of inattention could result in injury.

In rough sea conditions, use both hands to control heavy passage doors – When entering through a doorway look up and look down to avoid striking head and feet on doorframe – Always face the door when both opening and closing the door – Never attempt to open or close a watertight door while holding an object in your hands – Never lose contact with door. Always grasp door with at least one hand – Never grasp a door by its edge. Always hold the door by an inside or outside handle.

If regulations will allow, consider installing a door closure device designed to aid door control and stability.
