Talking Points: Grinding Discs For use during onboard safety meetings

ISSUE: 1 JULY 2012

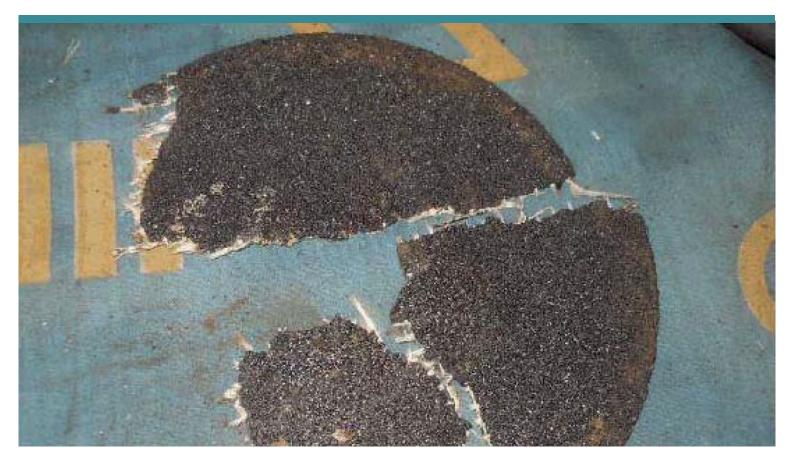
A shattered grinding wheel cutting disc.

A Injuries can be serious and even fatal. Fragments of the shattered cutting disc will fly towards the operator at high speed. Injuries to the face and eyes are most common.

- A Discs shatter for different reasons including, but not limited to, the following: -
 - Using a damaged grinding wheel
 - Using the wrong type of disc for the job
 - A mismatch between disc speed and machine speed
 - Poorly maintained machines or poorly fitted discs
 - Lack of operator training
 - Careless operation

- Only use good quality discs suitable for the job in hand
 - Never operate the machine without the guard in place
 - Always wear appropriate PPE
 - Training of personnel in proper use of the machinery
 - Grinding discs and wheels should be well maintained
- Q What does it say in our risk assessment concerning this equipment?
- A Please review your onboard procedures for grinding machines and power tools.
