Working through COVID-19: Steel Pre-Load Surveys

CARGO

ANNEX 2: ASSESSING THE PRE-SHIPMENT ORDER AND CONDITION OF THE CARGO

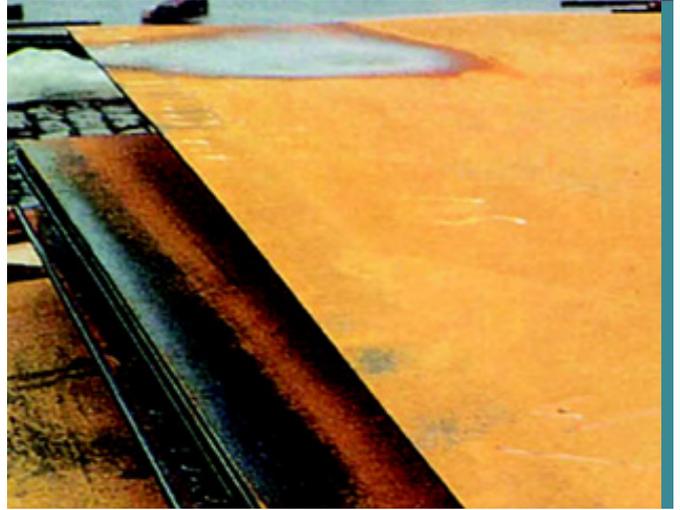
Steel plates.
Clause: rust stained, wet before shipment

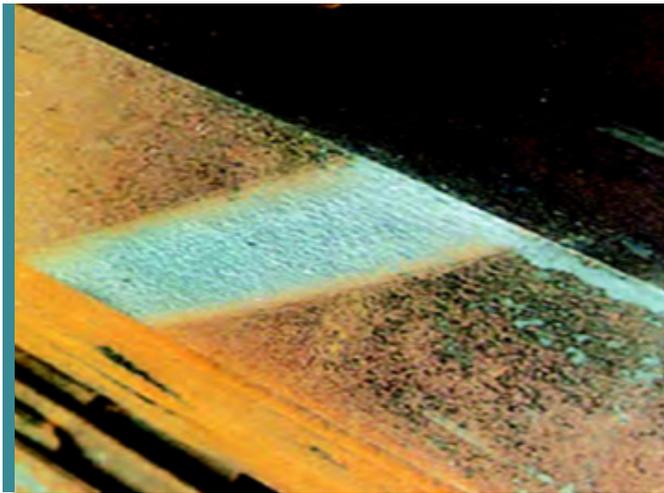
Channels and angles (rust cleaned away locally).
Clause: rust stained

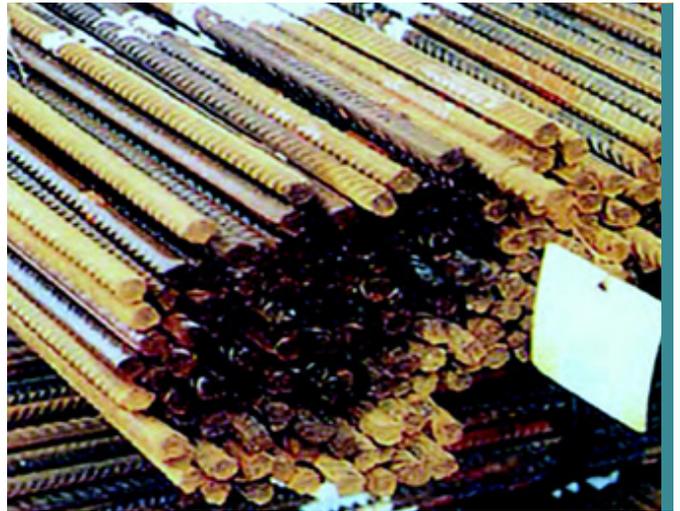
Reinforcing bars in bundles with dampness evident.
Clause: rust stained, wet before shipment

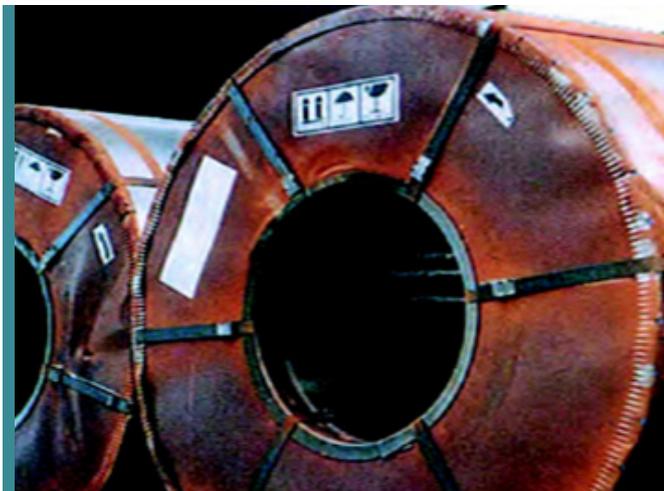
Wrapped coils. Clause: packing rust stained

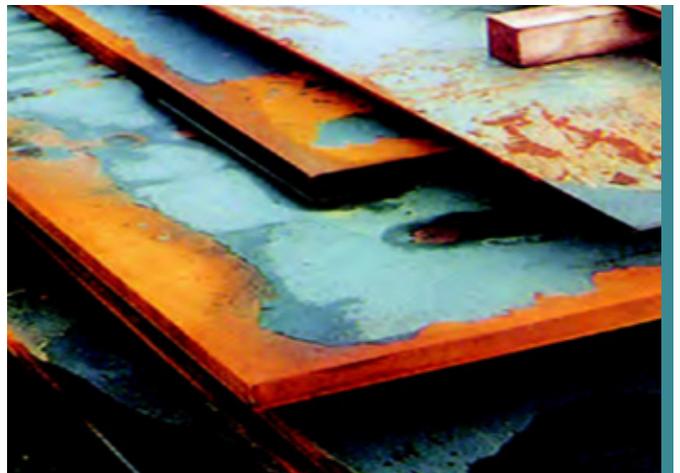
Plates with most mill scale intact, but handling has also fragmented mill scale from edges.
Clause: partly rust stained, wet before shipment

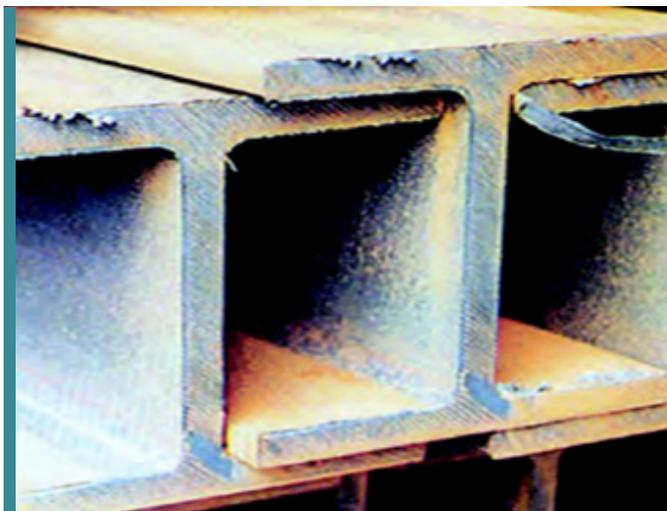
Beams with some mill scale still intact but rust encroaching on flanges and webs. Note correct nesting position. Clause: rust stained

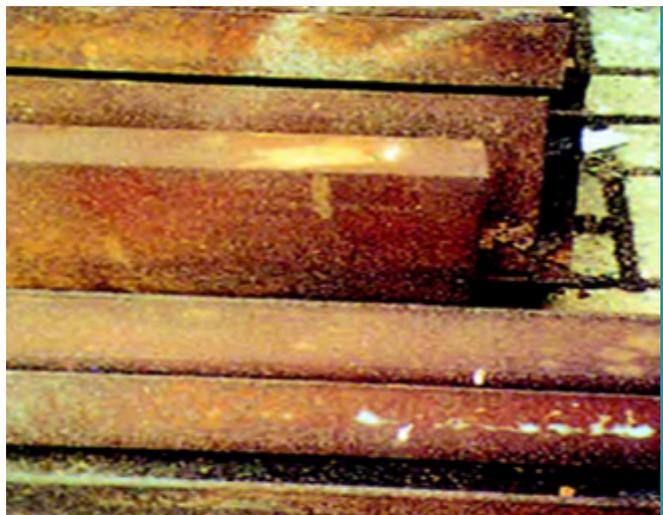
Channels.
Clause: rusty

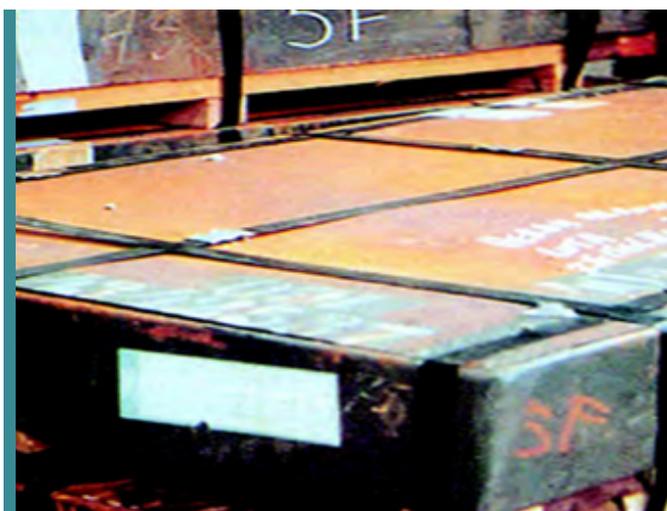
Wrapped packages of steel plates.
Clause: packing partly rust stained

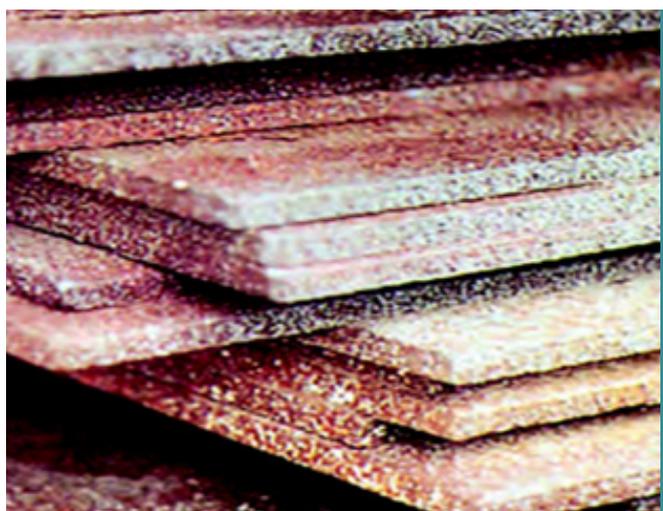
Plates.
Clause: rust with pitting

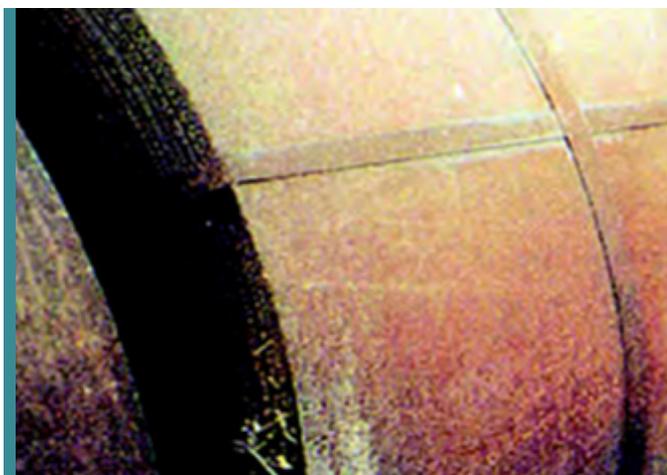
Hot-rolled steel coils.
Clause: rusty

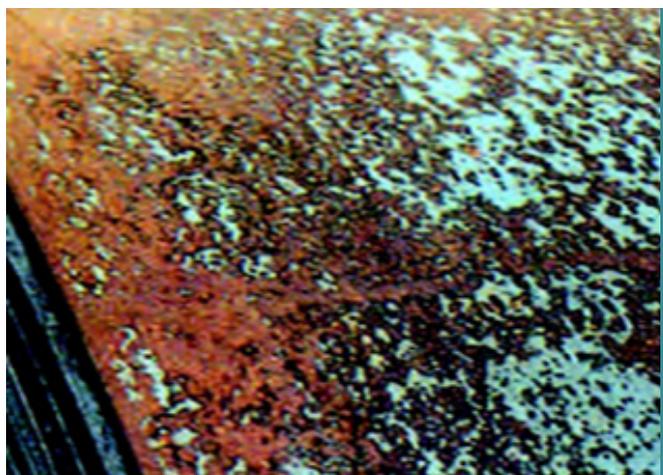
Hot-rolled steel coil.
Clause: rust stained, rust spots apparent

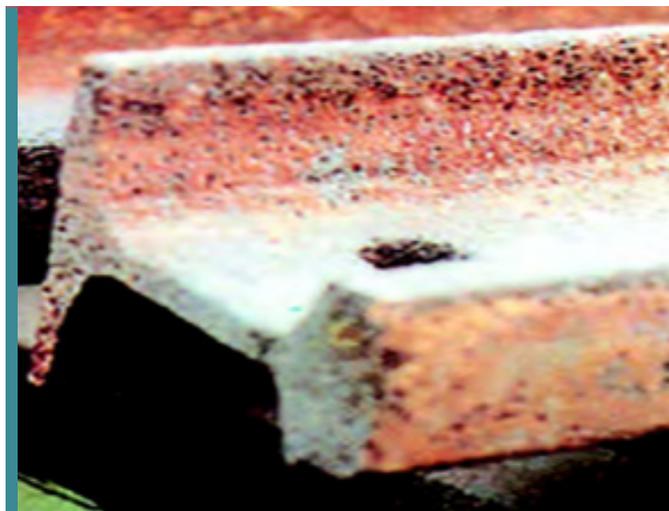
Rails.
Clause: rust with pitting

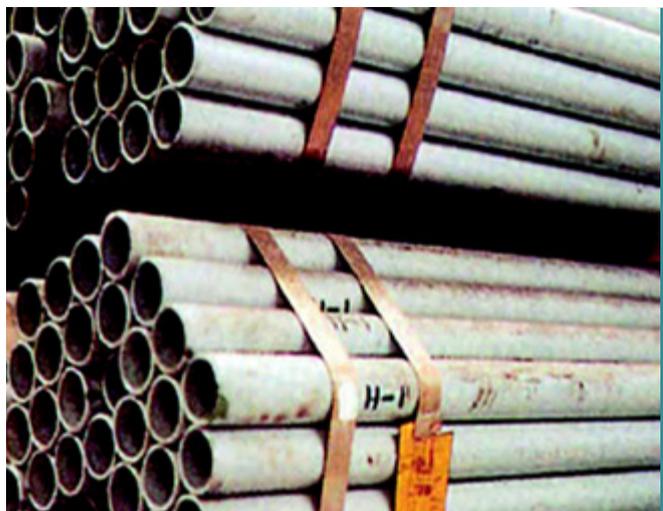
Channels. Galvanised pipes bundles showing no evidence of having been subjected to a passivation process.
Clause: galvanising dull

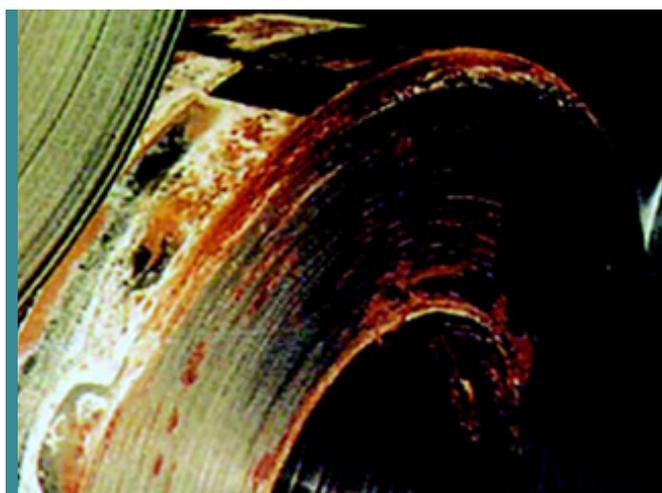
Galvanised coils (with wrappers removed).
Clause: galvanising affected by white rust

- **Galvanising affected by white rust:** Zinc coating heavily oxidated and covered in voluminous white coloured rust.
- **Galvanising dull:** Zinc coating losing lustre as a result of early oxidation.

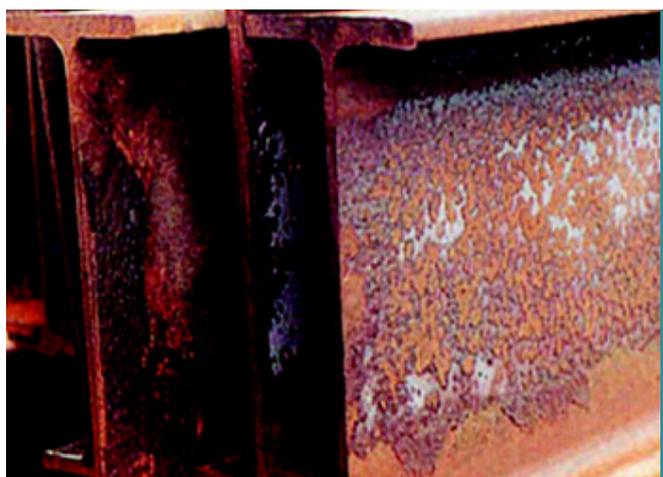
Beams with flaking mill scale on webs.
Clause: rust stained, rust spots apparent

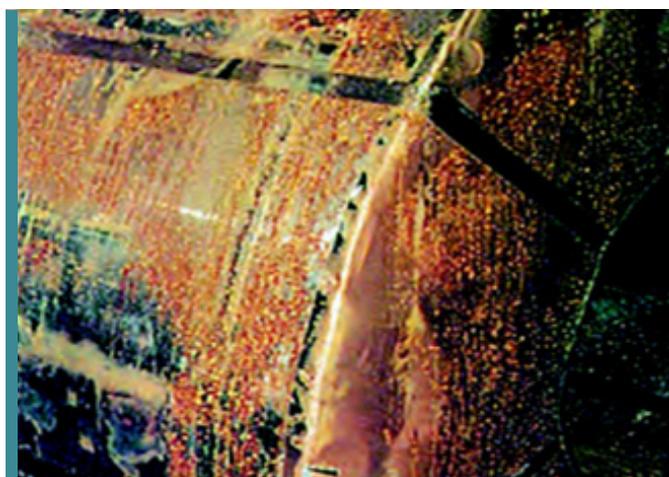
Wrapped coil with streaky rust brought about by dripping water from 'cargo sweat'.
Clause: packing rust stained, streaky rust indicates previous contact with water

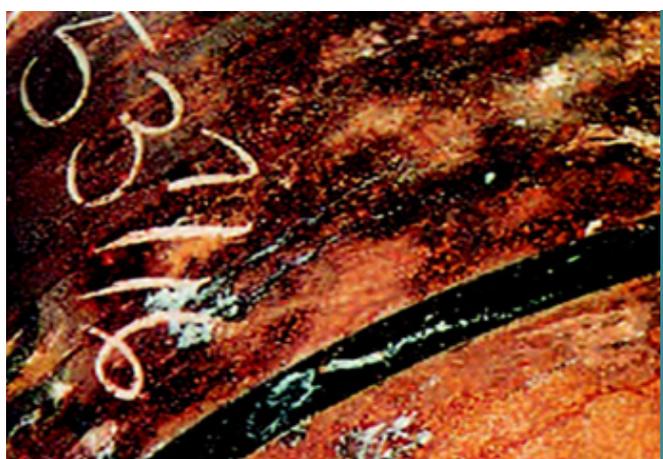
Hot-rolled coil which has been in contact with chlorides, suspect indications being configuration and colour of the rust. Clause: [rust clause applicable] + surface areas reacting to silver nitrate solution tests

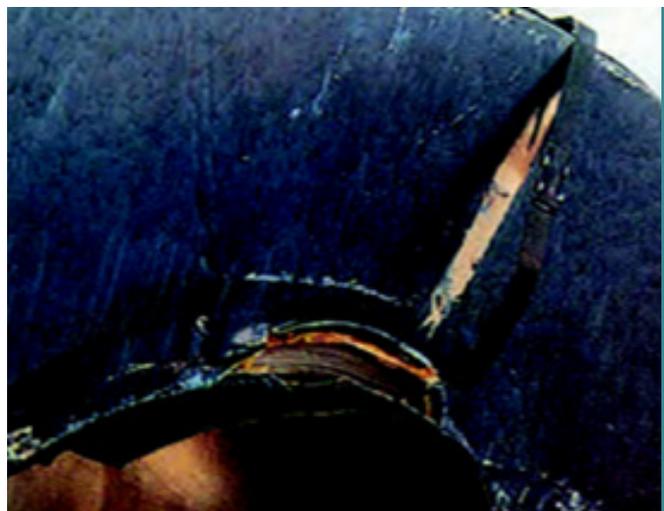
Wrapped coil damaged by forklift.
Clause: open in one place at inner circumference. Visible cargo is scored. Affects 15 windings

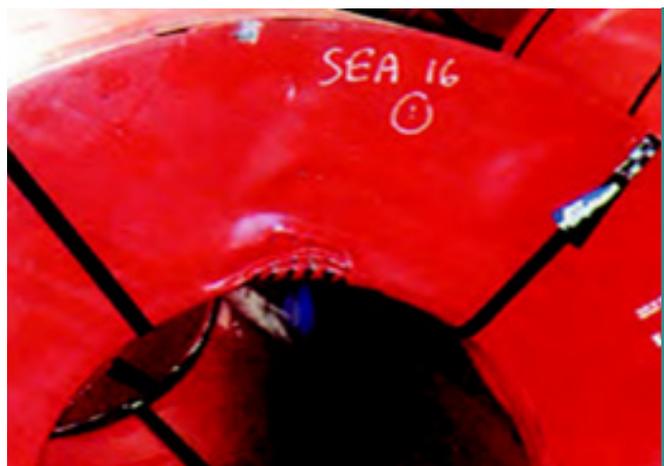
Wrapped coil damaged by lifting clamp.
Clause: packing edges at inner circumference dented where handling gear marked
Additional clause: packing torn

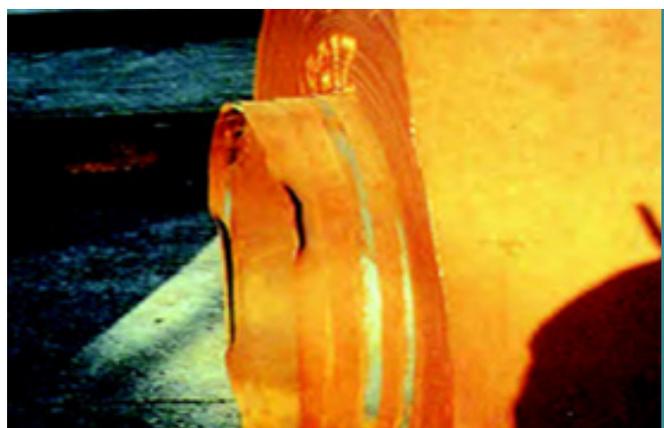
Telescoped coil.
Clause: windings at core telescoped up to 150 mm

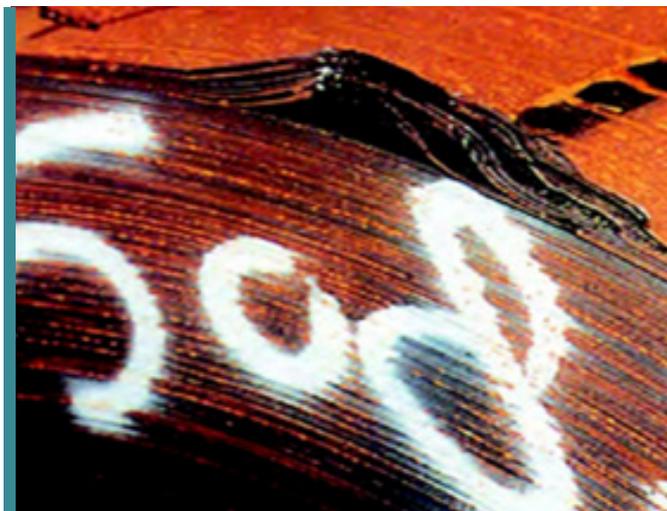
Coil damaged by forklift.
Clause: edges buckled at outer circumference where handling gear marked. Affects six windings

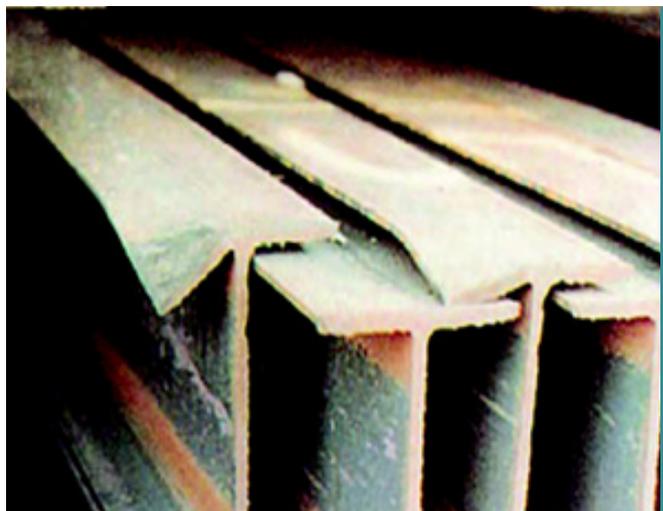
Nest of beams.
Clause: (left hand beam): flange bent in one position at end

- Flange bent in: Note the number of positions and at which locations location. The flange of a structural section is bent in a number of positions at a particular location.

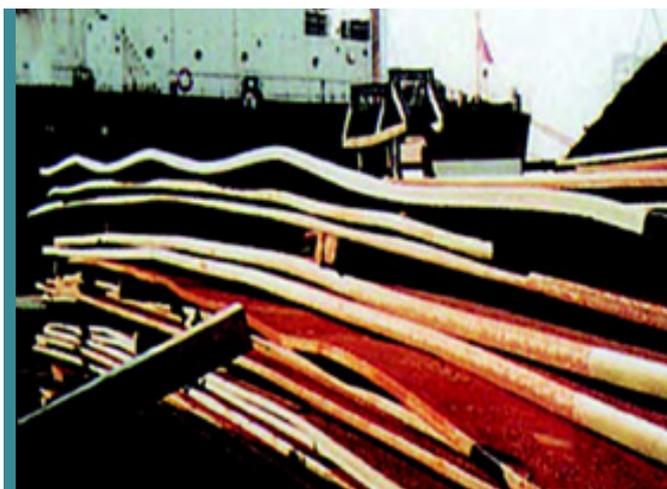
Plates.
Clause: edges waved along entire length

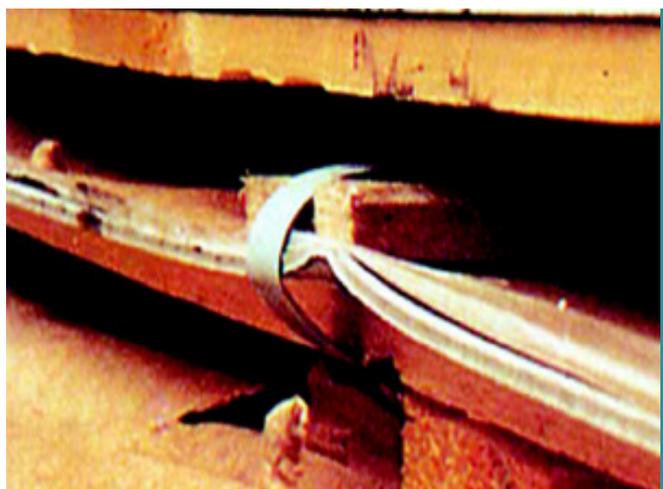
Bundle of stainless steel plates.
Clause: edges dented at center where handling gear marked. Affects two plates

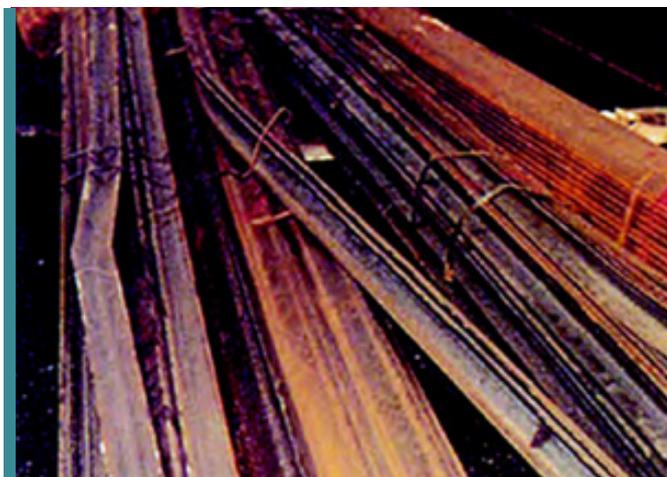
Bundles of light scanning pieces. Clause: (second bundle from left): bundle pieces bent along entire length. Affects two pieces. Strapped insufficiently, one strap broken, three missing

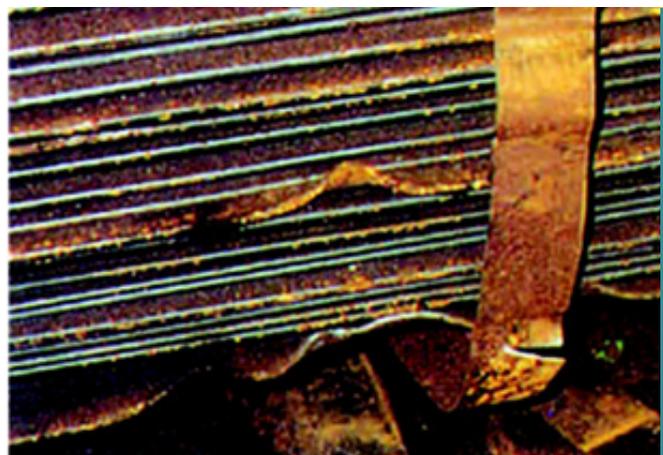
Bundle of angles overlying bundle of plates.
Clause: (angles): edges dented at bottom centre where handling gear marked. Affects two pieces. Strapped insufficiently, one strapping band broken
