# Hatch Cover Supplement

## An expensive problem with a low-cost solution

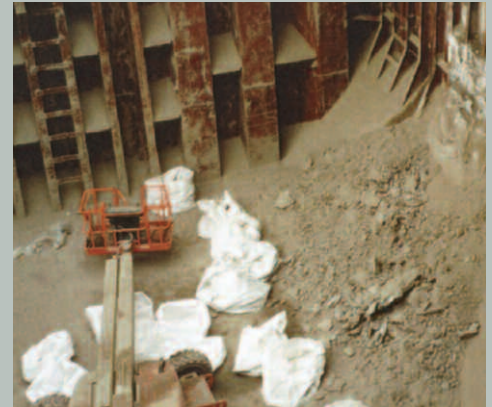
Water damaged cargo

The mention of cost of improvement is pertinent because the imbalance between this and the cost of failure to maintain weathertight integrity can be enormous. For example, in North of England alone there are typically three or four claims each year valued between \$500,000 and \$1,000,000 for water-damaged cargoes resulting from hatch cover defects – not to mention numerous smaller claims. In general, the cost of preventing these losses can usually be measured in a few thousand dollars or less – such as replacing some defective rubber seals, repairing some minor steelwork or sometimes just cleaning down a coaming before closing the hatch covers. This supplement aims to show just how easy it can be to avoid costly failures.

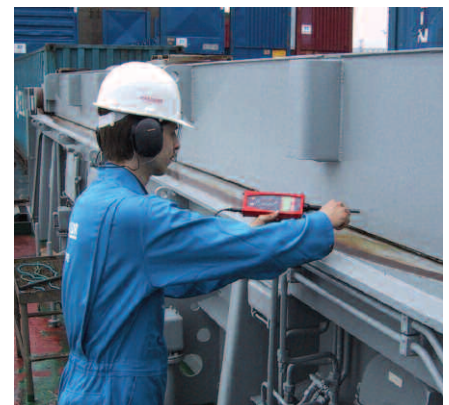
Ultrasonic testing

Ultrasonic leakage detection equipment was introduced some years ago to overcome difficulties with the hose test. An ultrasound transmitter is placed in the empty hold or on top of the cargo stow, with the hatch covers closed. An ultrasound detector is then moved by the surveyor around the outer sides of the cover and the cross-joints to locate any leaks.

In addition, the Association requires that any leaks detected by ultrasound testing equipment do not exceed 10% of the "open hatch value", which is a control reading determined at the start of the test. Readings in excess of 10% will require defects to be properly rectified before the vessel sails if the ship's operators are to be able to demonstrate that they have exercised due diligence to make the ship seaworthy at the commencement of the voyage.

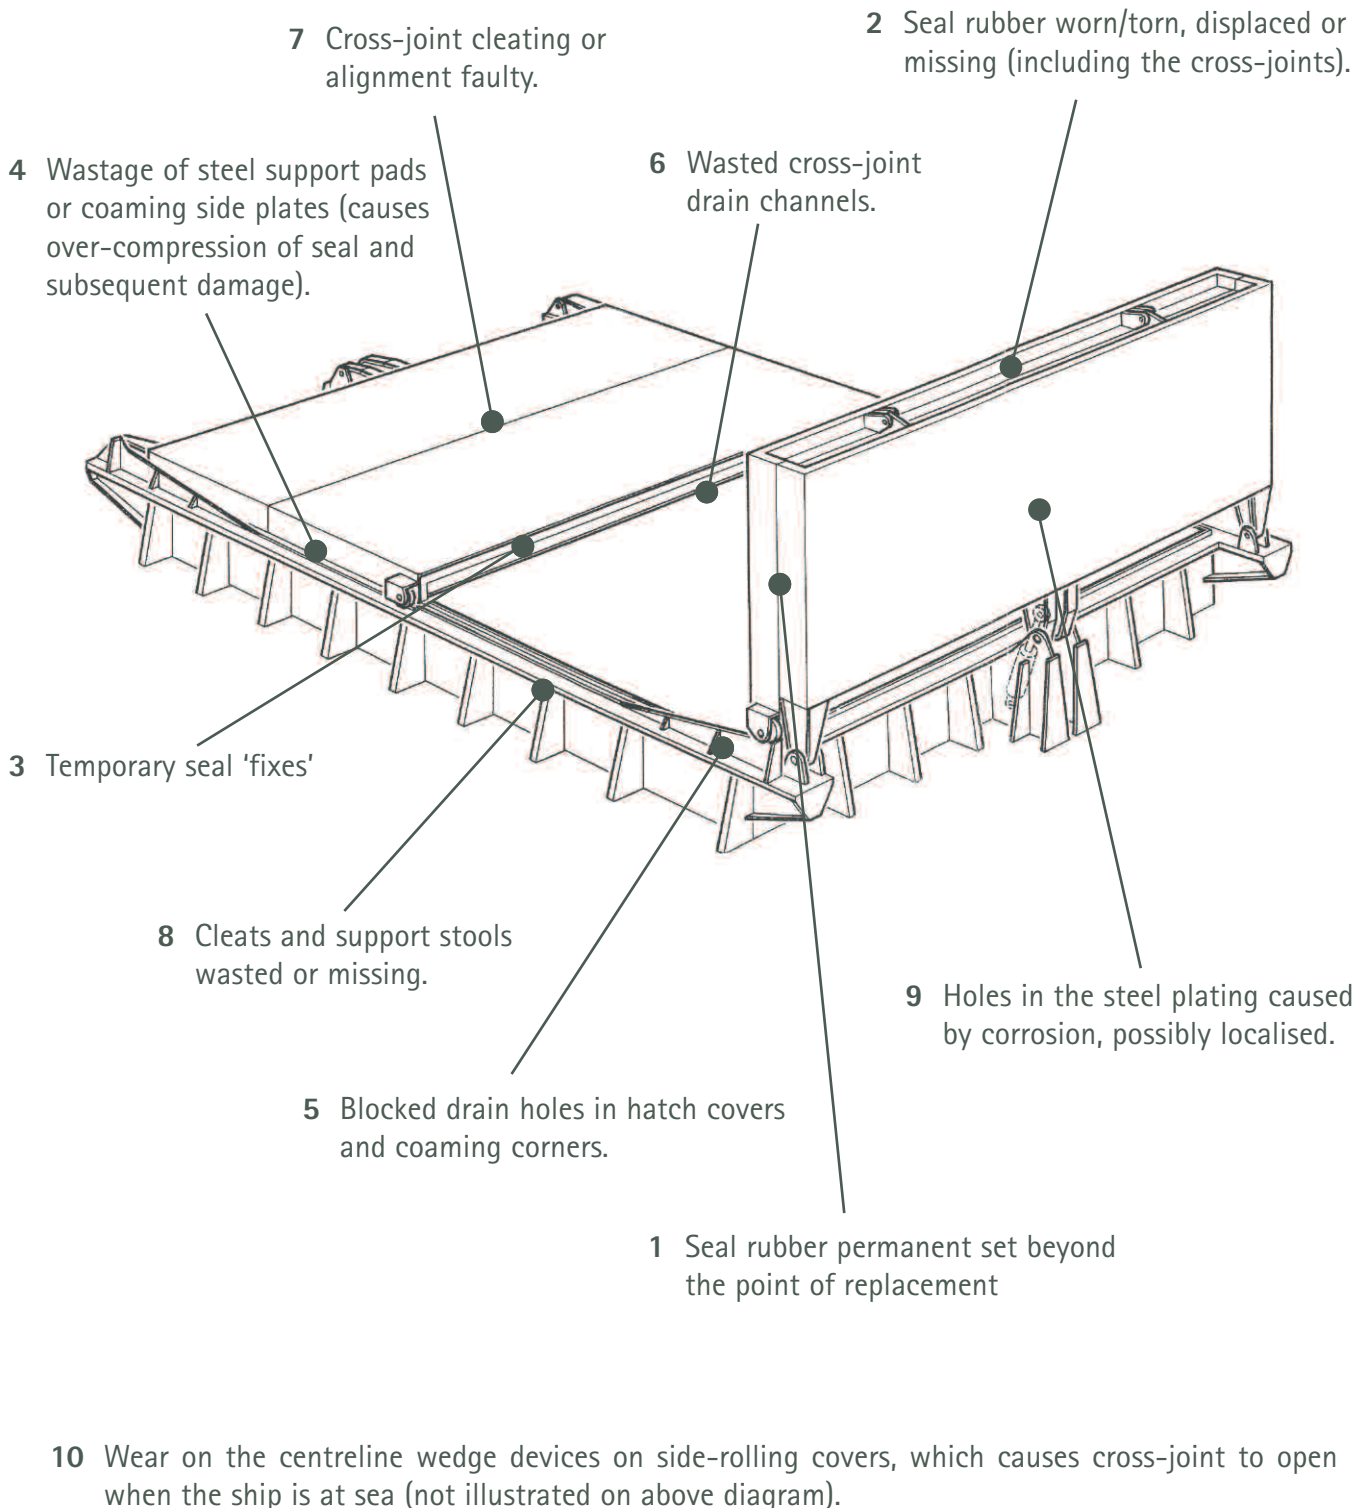
# Top 10 hatch cover defects

The top 10 hatch cover defects giving rise to claims for water damage are based on experience of many hatch cover surveys and damage claims. In most cases, the cost of early remedial work which would avoid possibly significant claims is not large.

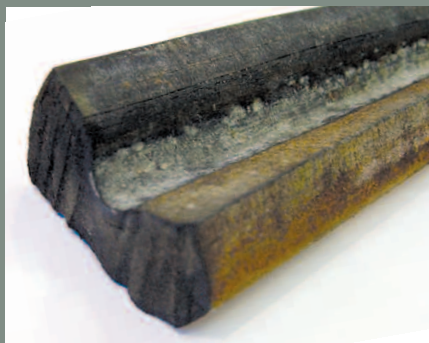
*Permanent Set*

More commonly, the over-compression causes the elasticity of the seal to be lost resulting in a deep groove in the rubber known as 'permanent set'. It is quite easy to measure the depth of the permanent set using a ruler or a gauge. This should then be compared to the designed compression of the seal (to be found in the hatch cover operating and maintenance manual that will be onboard). The simple rule for replacement of the seal is:

**When permanent set reaches half the design compression – replace the seal.**
