1. What is shown in the picture?
2. What injuries may be caused by the failure of this piece of equipment?
3. What are the main causes of this type of failure?
4. What steps can we take in order to protect ourselves from this hazard?
5. What does it say in our onboard risk assessment concerning the use of this equipment?

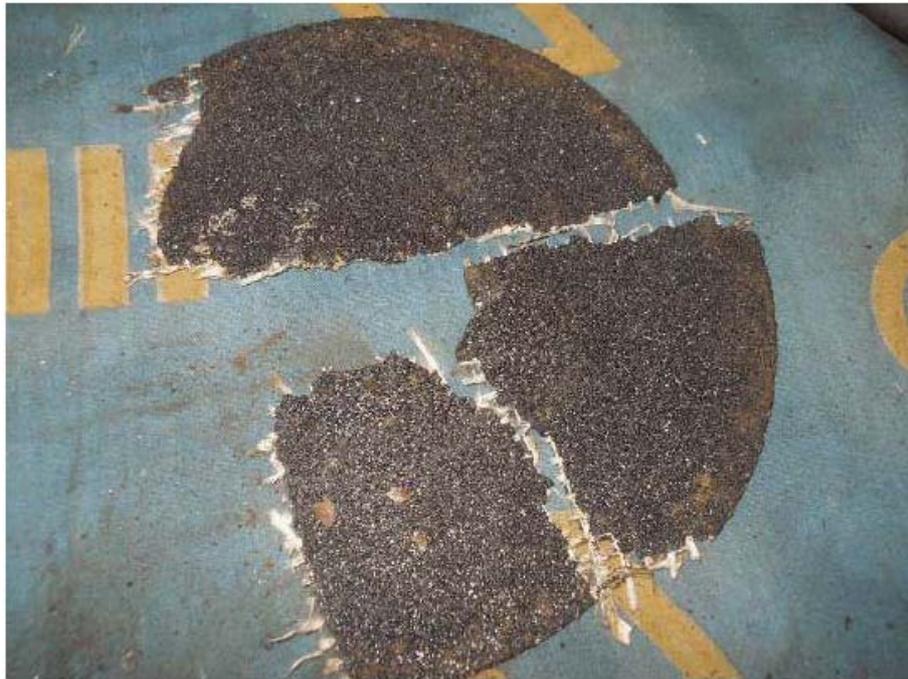
*A shattered grinding wheel cutting disc.*

*Injuries can be serious and even fatal. Fragments of the shattered cutting disc will fly towards the operator at high speed. Injuries to the face and eyes are most common.*

*Discs shatter for different reasons including, but not limited to, the following: -*

- *Using a damaged grinding wheel*
- *Using the wrong type of disc for the job*
- *A mismatch between disc speed and machine speed*
- *Poorly maintained machines or poorly fitted discs*
- *Lack of operator training*
- *Careless operation*

- *Only use good quality discs suitable for the job in hand*
- *Never operate the machine without the guard in place*
- *Always wear appropriate PPE*
- *Training of personnel in proper use of the machinery*
- *Grinding discs and wheels should be well maintained*

*Please review your onboard procedures for grinding machines and power tools.*
