Diagram from UK MCA MGN 308

1. What is shown in red in the picture?
2. Do you know why these areas are dangerous?
3. Are you aware of these areas on your ship?
4. Should these areas be permanently marked on your vessel?
5. What does it say in your onboard risk assessment and safety management system concerning mooring operations?

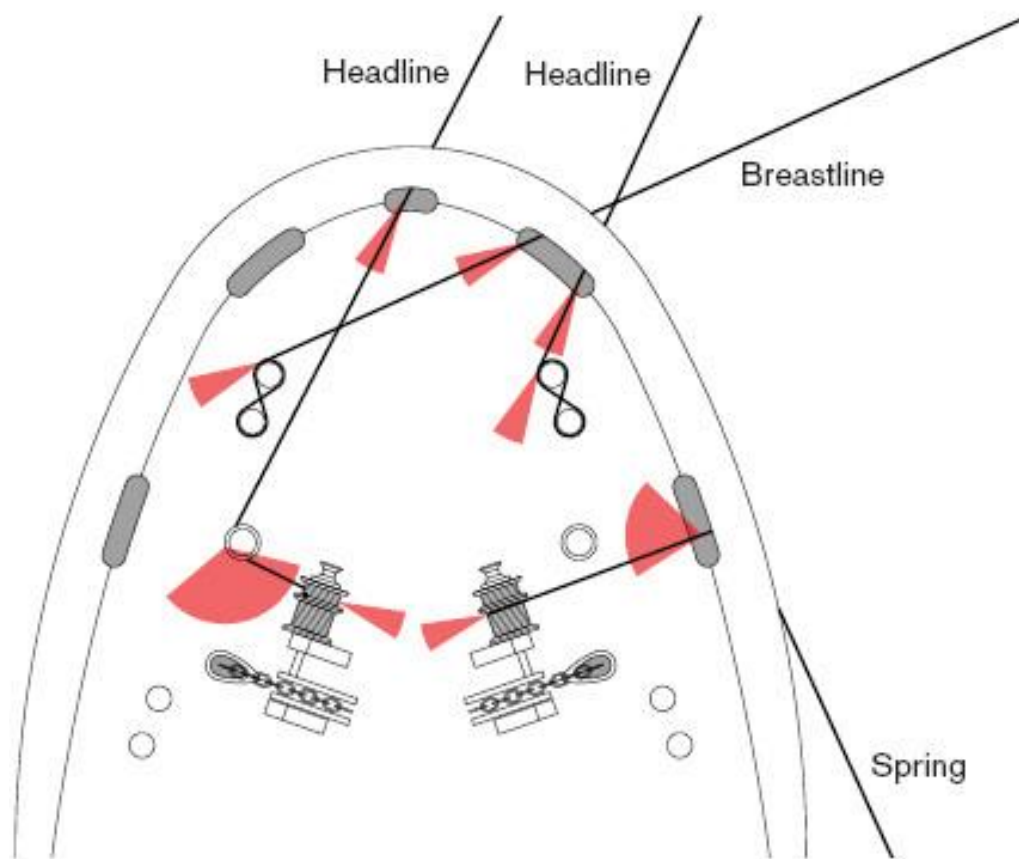
Snap back zones.

Any mooring line under tension has the potential to fail. Should failure occur the elasticity in the line will cause it to snap back with great force towards its secure point (e.g. bollard or winch drum). Anyone standing in a snap back zone during line failure may be seriously injured, or killed, due to the very large forces involved.

Any person likely to be involved in mooring operations should be aware of the potential snap back zones aboard their vessel. Take time to explain the location of snap back zones on the ship prior to each mooring operation.

Mooring is a dynamic operation where the crew members are constantly responding to a changing situation. If your vessel calls at a variety of ports, it will most likely use a different mooring configuration for each one. It would therefore not promote safety to permanently paint snap-back zones applicable for all situations on a relatively small deck area.

[UK MCA's MGN 308 \(M & F\)](#) and [COSWP 25.3.10](#) recommend that a bird's eye view of the mooring deck arrangement is produced which can then be utilised as a means of identifying danger areas during the initial Toolbox Talk.
