# GUIDELINES FOR THE CARRIAGE OF CARGO IN NON-OPERATING REEFER CONTAINERS

CONTAINER OWNERS ASSOCIATION

## **COA Guidelines**

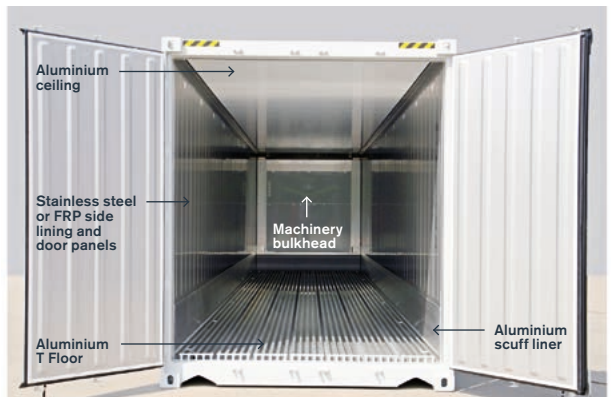
**Picture 1**

Interior view of a refrigerated container showing aluminium T-Floor and scuff liner, stainless steel or Fibre Reinforced Plastic (FRP) sidewalls, white painted aluminium ceiling, machinery bulkhead at far end.

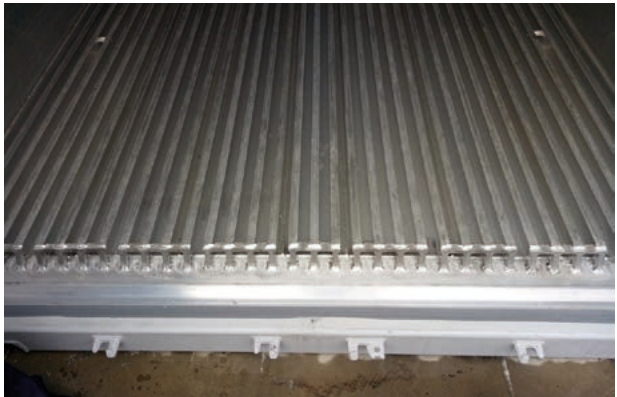
**Picture 2**

Close up of aluminium T Floor. This is an in-service container with some minor discoloration but otherwise in good condition.

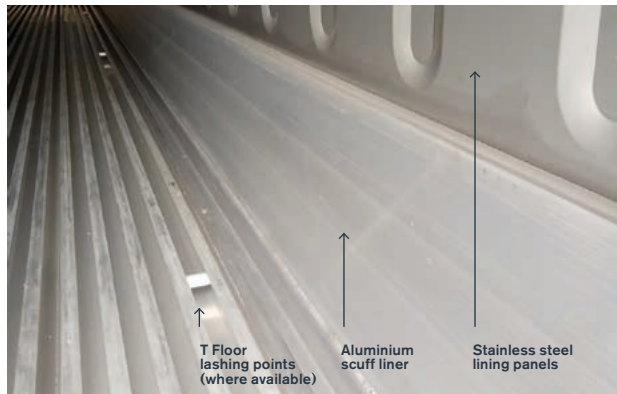
**Picture 3**

Interior floor/sidewall interface showing lashing points and exposed metal surfaces. Note that there may be no lashing points in the floor.

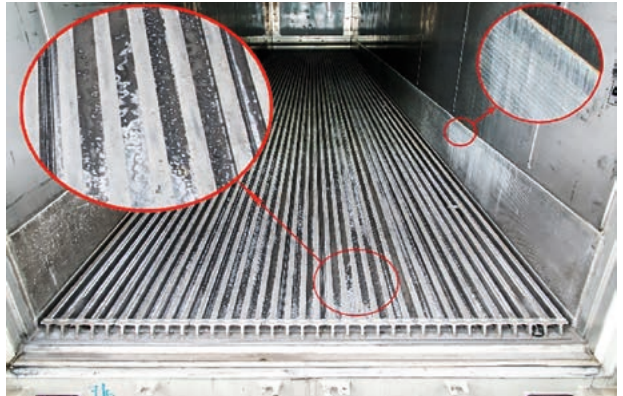
**Picture 4**  
Corrosion to aluminium T Floor and scuff liner.

There are various causes for the type of corrosion that are presented in Picture 4. Although the most common cause is the cargo itself, including treatments (e.g. residues of fumigation) that might be applied to the cargo, cleaning with caustic materials will also cause corrosion or oxidation to the interior of the unit. Note that fumigation is not allowed in operating reefers; shippers should ensure fumigated cargo is adequately ventilated before packing the container. It is difficult to treat and permanently repair this corrosion as the surface of the aluminium has had its protective oxide layer contaminated.

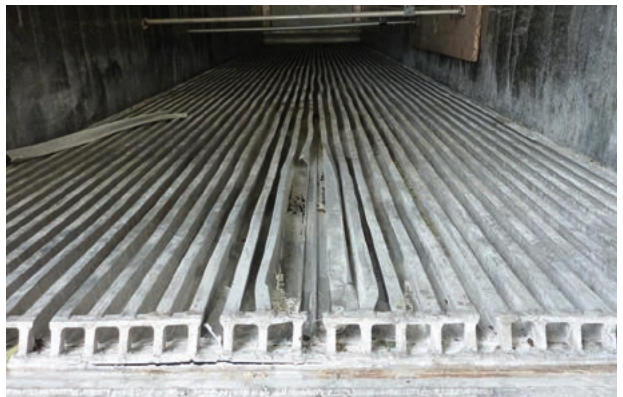
**Picture 5**  
Badly damaged aluminium T Floor showing broken T sections, cracks to the welds which will require major and expensive repairs.

In addition to corrosion, the aluminium T Floor sections are susceptible to mechanical damage, such as caused by fork or pallet truck wheels.

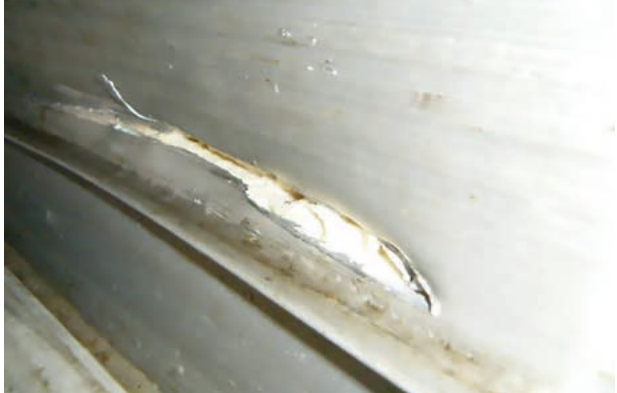
**Picture 6**

Forklift or cargo damage to the aluminium scuff liner showing the insulation foam underneath.

Most reefer interior sidewalls are protected by aluminium scuff liners. Aluminium is a softer material than the steel used in GP containers, so can be more easily cut by forklifts used during the packing/unpacking process or by the sharp edges of packaging, such as pallets. Some reefers use Fibre Reinforced Plastic (FRP) as lining material, which is more resistant to damage. Cuts in the scuff liner or sidewall, as shown in Picture 6, allow moisture into the insulating foam that needs to be repaired before the insulation deteriorates.

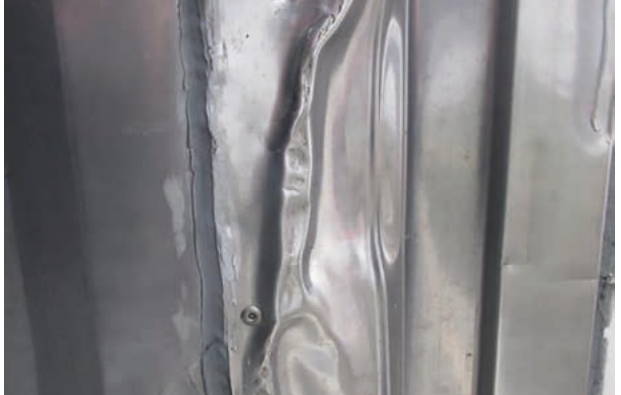
**Picture 7**  
Cargo damage to the stainless steel side lining.

While reefer interior sidewalls might be made from high strength stainless steel it is only 0.7mm thick compared to the 1.6mm or 2.0mm Corten steel used for GP containers. Stainless steel sidewalls are therefore more easily damaged, as in Picture 7, and require more complex repair.

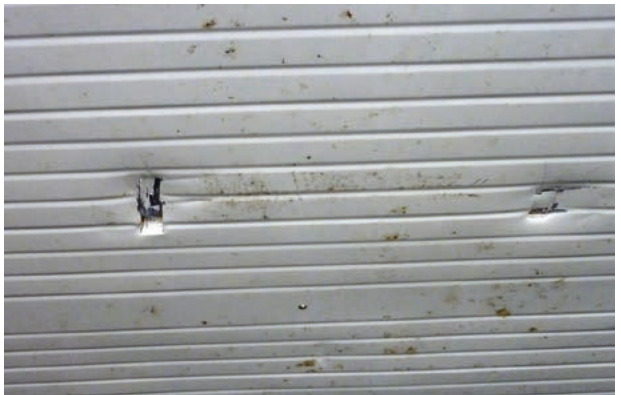
**Picture 8**  
Cargo or forklift truck mast damage to the aluminium ceiling panels.

The thin panel aluminium ceilings are significantly easier to damage than the Corten steel used in the roofs of GP containers. Such damage, showcased in Picture 8, exposes the insulation foam and must be repaired to prevent moisture absorption.

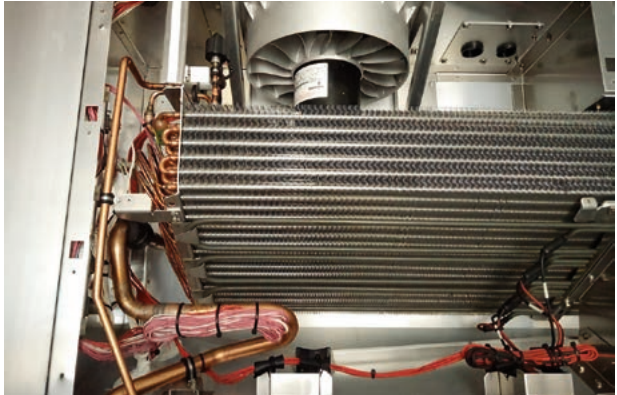
**Picture 9**  
View of reefer machinery on a new unit with the bulkhead removed.

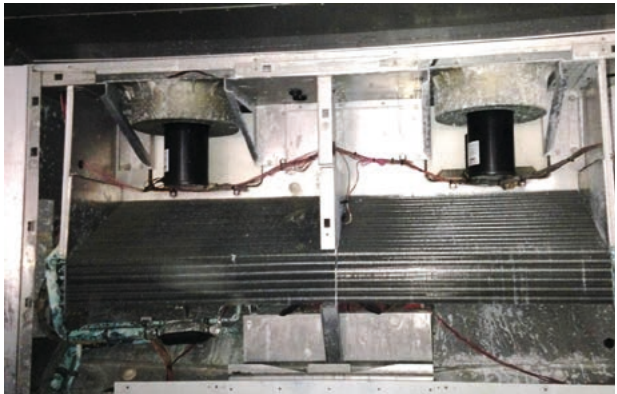
**Picture 10**  
View of corroded reefer machinery with the bulkhead removed. Note the white corrosion or oxidation to the aluminium fan housing and the copper corrosion to pipes. The damage is most likely resulting from previous cargo or a cargo treatment, but whatever the actual cause, inadequate operational controls (including excessive cleaning) are likely to lead to costly repairs being required.

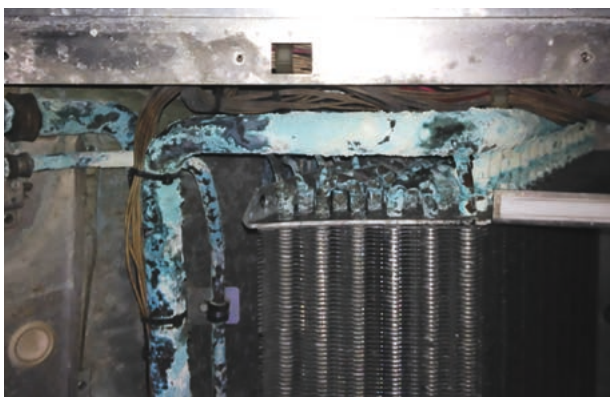
**Picture 11**

Close up view of corroded reefer machinery copper pipes.

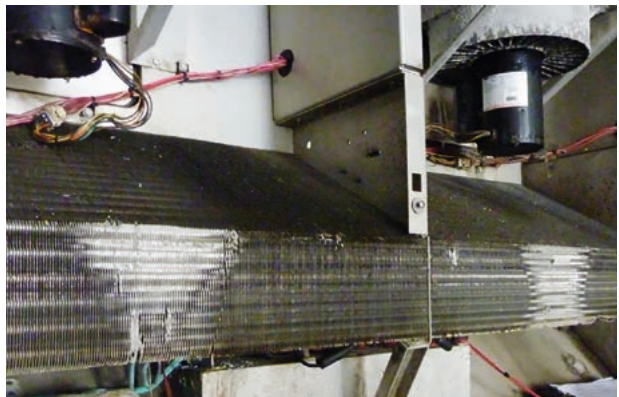
**Picture 12**  
Damage to the evaporator coils.

A hard impact to the aluminium bulkhead can damage the evaporator coil behind it, crushing the fins or flattening the refrigerant tubes (see Picture 12). Damaged coils will inhibit airflow and the ability to maintain temperature settings for future temperature controlled cargoes.

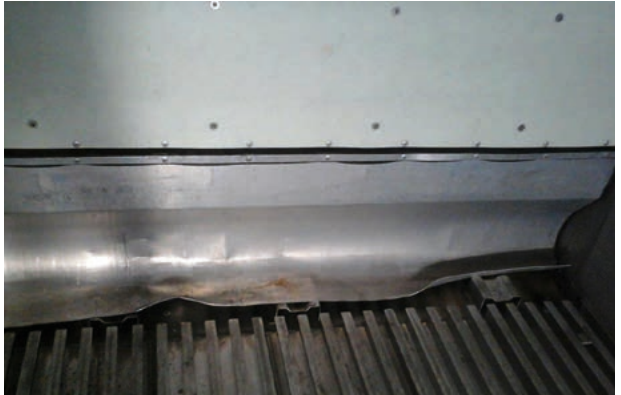
**Picture 13**  
Damage to machinery airflow baffle.

Picture 13 shows damage to the machinery airflow baffle. Cargo that is slid along the floor and pushed into the bulkhead can bend back the air baffle plate which will require replacement.

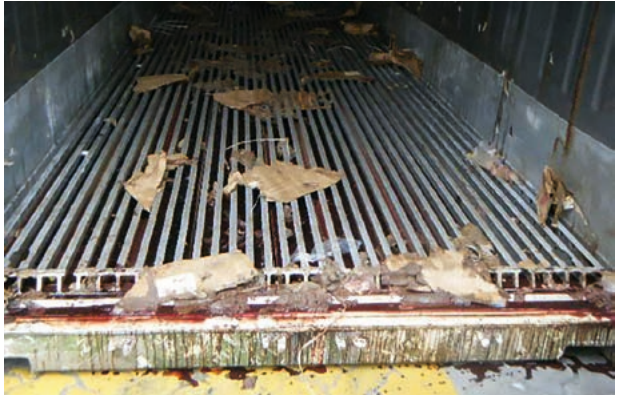
Picture 14

Poorly maintained and/or cleaned reefers, as shown in Picture 14, are unsuitable for use with refrigerated food products, flowers or pharmaceuticals.

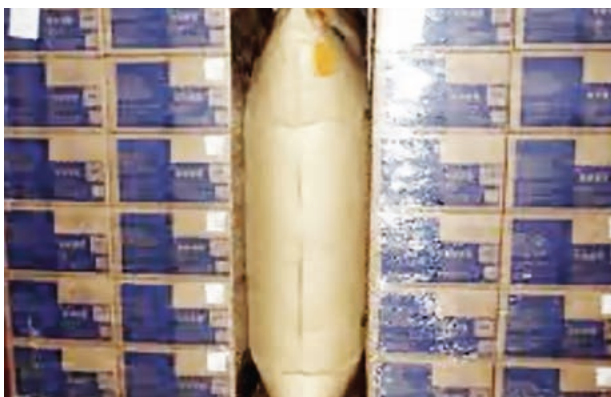
**Picture 15**

- Use of air bags for dunnage against the sidewalls, may cause severe damage to the unit. If air bags are used it is recommended that they should only be placed in the middle of the cargo. Picture 15 shows correctly placed in middle of cargo.

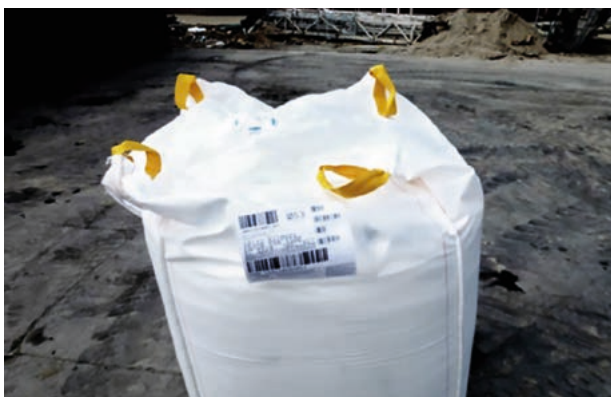
**Picture 16**

- FIBCs/Big Bags: When packing FIBCs the mass of the packed cargo should not exceed the maximum permissible payload or 27 tonnes, whichever is the lesser
- Cargoes that emit fine powders or grains should be packed in sift-proof and sealed FIBCs, an example is shown in picture 16. Packers should also consider stretch/shrink wrapping to prevent fine powders escaping from the FIBCs
- It is recommended to fit a false floor to reduce the risk of bag material tearing.

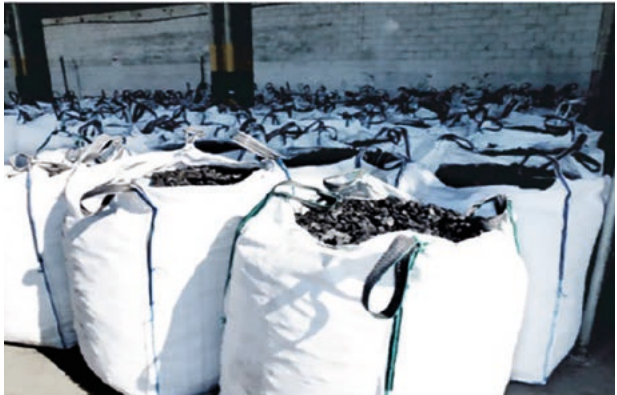
Picture 17

- Cargoes that are (a) inert such as dry plastic scrap, (b) do not emit vapours and (c) not excluded on the list in section 10, can be carried in standard open top or skirted top FIBCs. However, when open top FIBCs (see Picture 17) are used there may be additional costs incurred for cleaning any spillages after the cargo is delivered
- For FIBCs not packed on pallets, it is recommended that a false floor is fitted to reduce the risk of the FIBC fabric tearing.

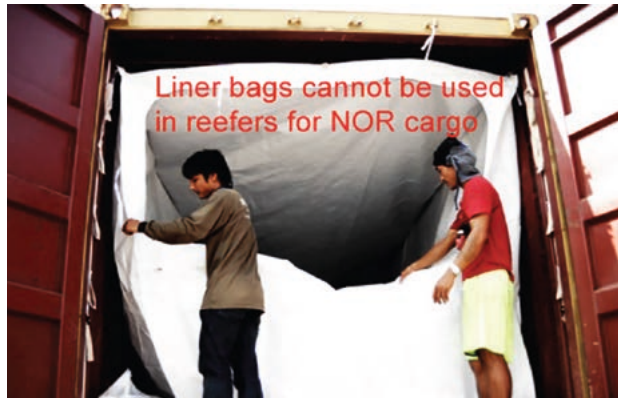
Picture 18

- Liner Bags, as shown in Picture 18, are not suitable for use in reefer containers, whether for temperature controlled or NOR cargo.

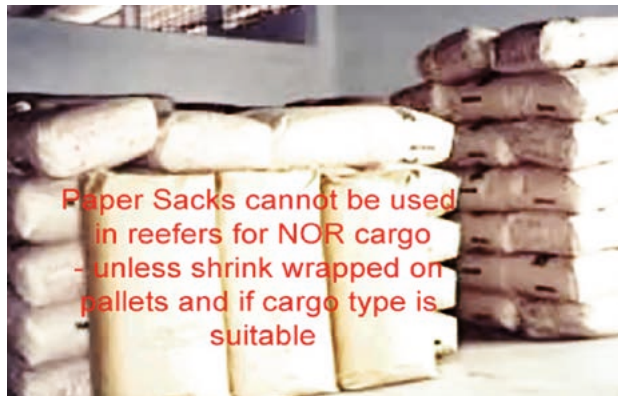
Picture 19

- Drums: Closed, sealed drums can be carried if securely mounted on pallets or if the T Floor and part of the sidewall are adequately protected with plywood. Drums should not be placed directly on to the T Floor or against the sidewalls
- Paper Sacks. When packed as non-palletised cargo, as in Picture 19, these are not suitable for use in reefer containers if they contain heavy or powdered products such as cement, fertilizers etc. Paper sacks packed and shrink-wrapped on pallets may be considered if the cargo type is acceptable.
