# Root Cause Analysis

## Root Cause Analysis

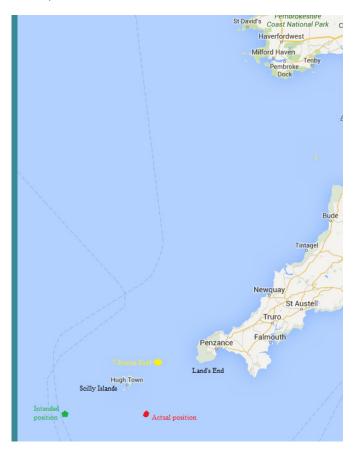
The 'Torrey Canyon' was loaded with 100,000 tons of crude oil bound for a terminal in Milford Haven, on the west coast of Wales. The ship was trying to catch the following evening's high tide, in order to enter port on arrival. The Scilly Islands were expected to be sighted off the starboard bow on the morning of 18th March 1967. In the event, the islands were sighted off the port bow. The master then made the decision, in order to save time, to pass between the Scilly Islands and Land's End, the south west tip of the UK mainland, rather than alter course to pass west of the Scillies, as per the original passage plan. The passage between the Scillies and Land's End is divided in two parts by the Seven Stones Reef and each of those parts has further obstructions within them. The master decided to take the western channel. He was not particularly familiar with the area, nor did he have the applicable copy of the UK Admiralty Sailing Directions - 'Channel Pilot' on board. The ship, still doing full speed, met some fishing boats in the western channel, which delayed it making a planned course alteration. When the master did order an alteration of course to the helmsman he realized, too late, that the ship was still on autopilot. The ship then grounded on Seven Stones Reef,

resulting in cargo tanks being ruptured and subsequent huge pollution. See the following map for the positions of the various salient points.

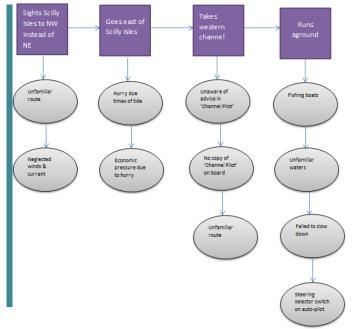
An events and causal factors chart of the incident might resemble that shown below (our thanks to Lloyd's Register Marine for granting us permission to use this chart):

A classic example of how an events and causal factors chart may be used in accident investigation is the 'Torrey Canyon' disaster of 1967. A brief summary of the incident follows:

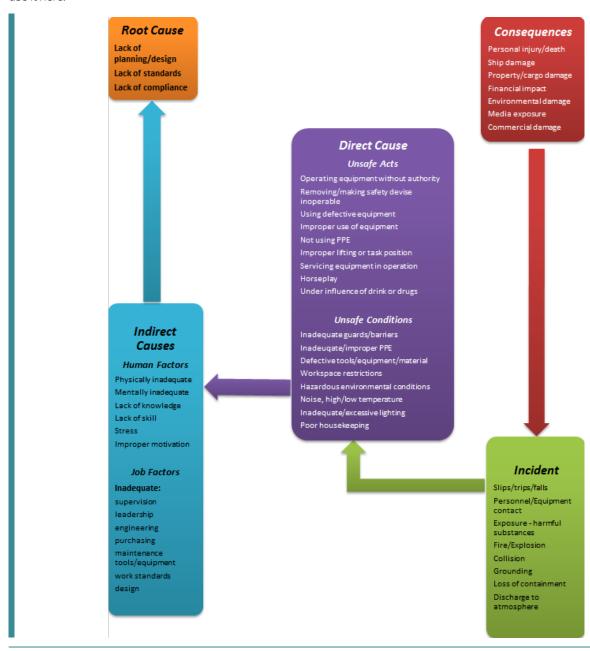
Once the events and causal factors charting have been completed (or whatever other tool has been used in the process), the investigation team can proceed to use the information gleaned to establish the root cause(s) of the incident being analysed. There are various propriety brands of RCA tools available on the market and only one type, an RCA Flowchart is shown here. You may wish to investigate other RCA tools and use those, if they feel that they are more appropriate. The flow diagram is a stepped process for drilling down through the incident causation chain to determine the true causes of an accident.

The flowchart below is adapted from that used by Lloyds Register Marine and we thank them for their kind permission to use it here:
