MARINE SAFETY ALERT

Safety Alert 06-20

RECOGNIZING FIRE HAZARDS & PROPER CARGO STOWAGE ON RO-RO VESSELS

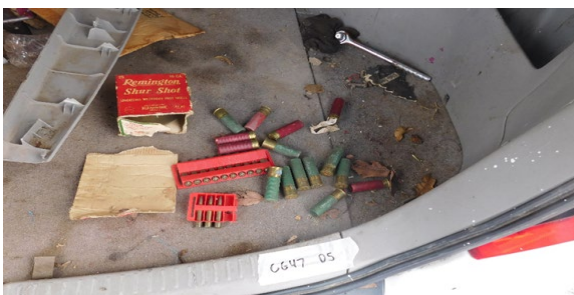
Ammunition found in trunk of vehicle from deck 5 of cargo ship, taken in June 2020, provided by the Coast Guard.

- Protect vehicle batteries against short circuiting, for example by disconnecting the battery if appropriate;
- Remove all personal and combustible material from vehicles prior to loading them onto a vessel;
- Inspect and remove leaking vehicles from the vessel prior to sailing and do not permit vehicles known to be leaking to be loaded onto the vessel;
- Verify receiving guidelines of shippers and charterers are in alignment with the IMDG Code to include fuel levels prior to loading.

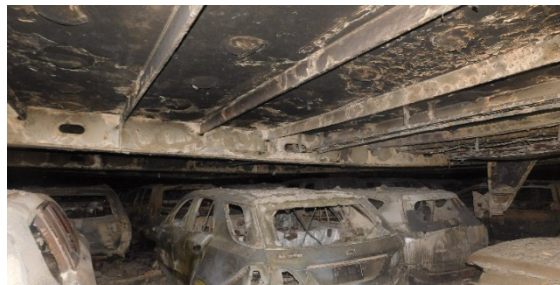
Cargo and structural fire damage on deck 8 of a cargo ship, taken in June 2020 provided by the Coast Guard.

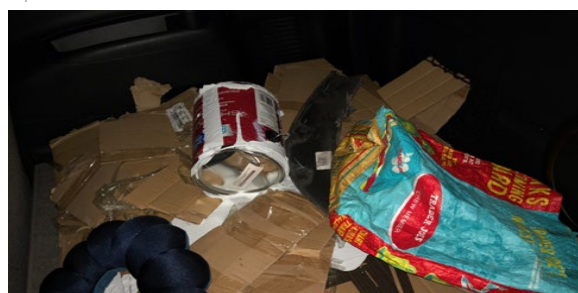
Paint and cardboard in a vehicle on deck 5 of cargo ship, taken in June 2020, provided by the Coast Guard.

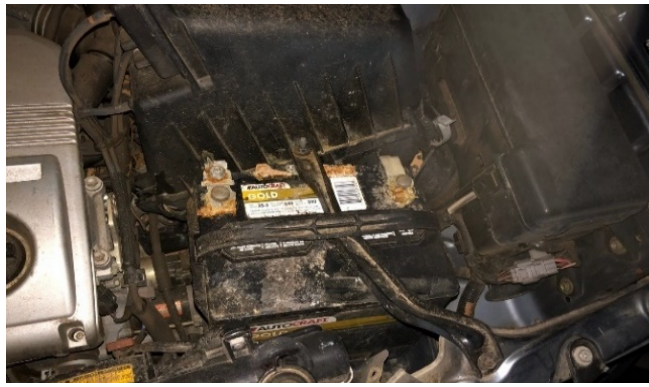
Heavily corroded battery with terminals still connected found in vehicle on Ro-Ro, taken in June 2020, provided by the Coast Guard.
